# Ares I-X 30 Day Report

*December 3, 2009*

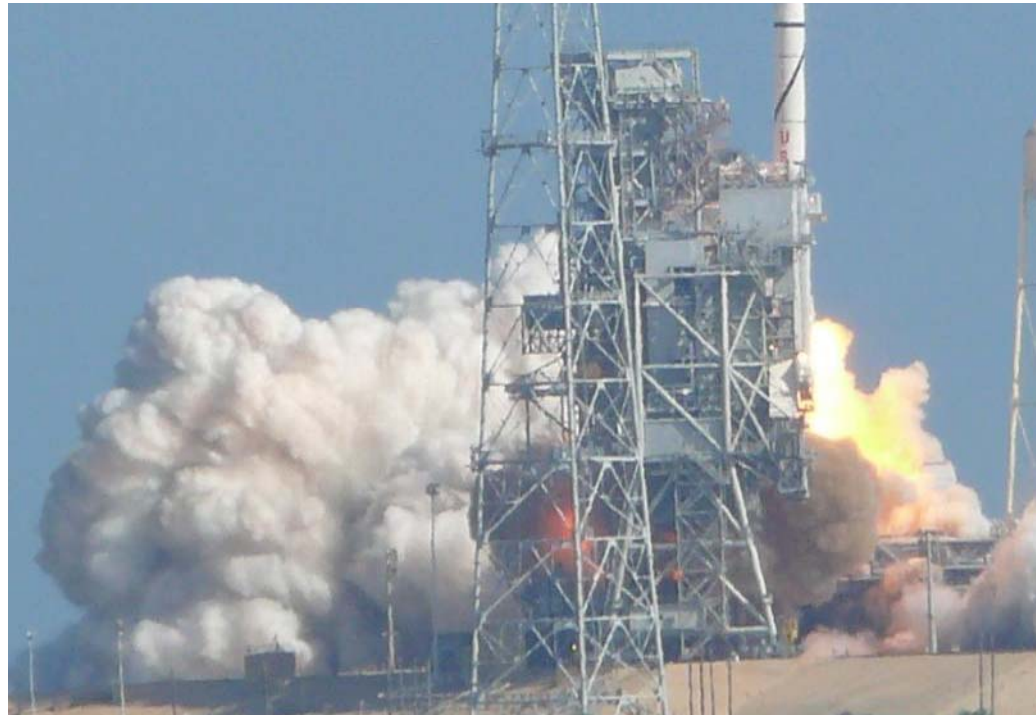
- ◆ **Completely successful Fly Away Maneuver**
  - Designed to protect higher level structures
- ◆ **Minor damage was expected at lower levels**
  - Considered acceptable
  - Shuttle has routinely causes some damage
  - Plume impingement locations were different than Shuttle that had not been hardened yet

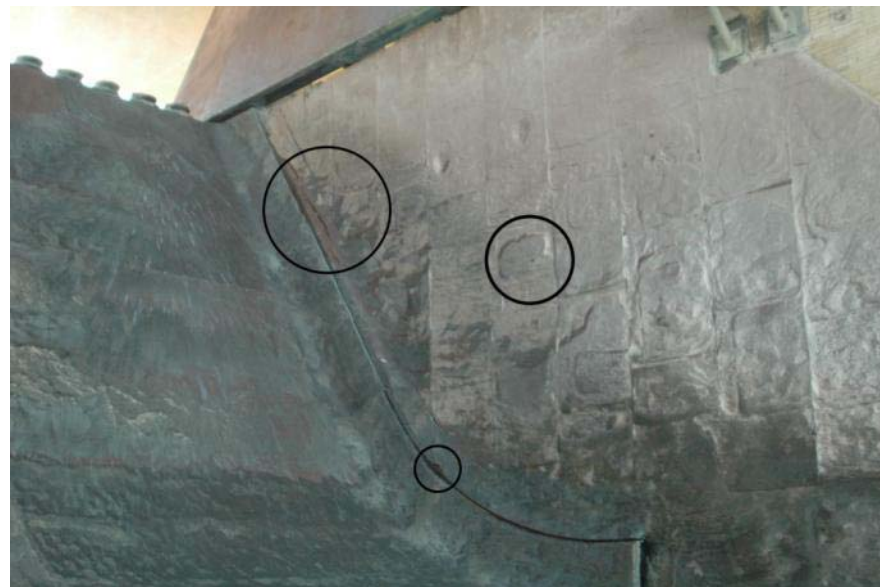
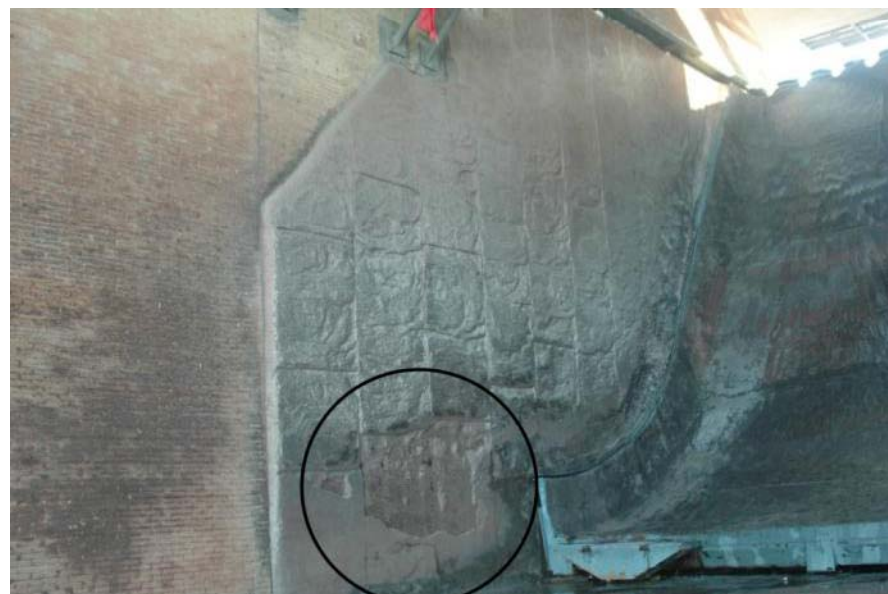
◆ **Also experienced some damage in the flame trench to the fondue fire.**

- West side wall had some damage on the flame fence wall. No obvious brick damage was observed.
- East wall damage was near a suspect location identified in the pre-launch inspection.

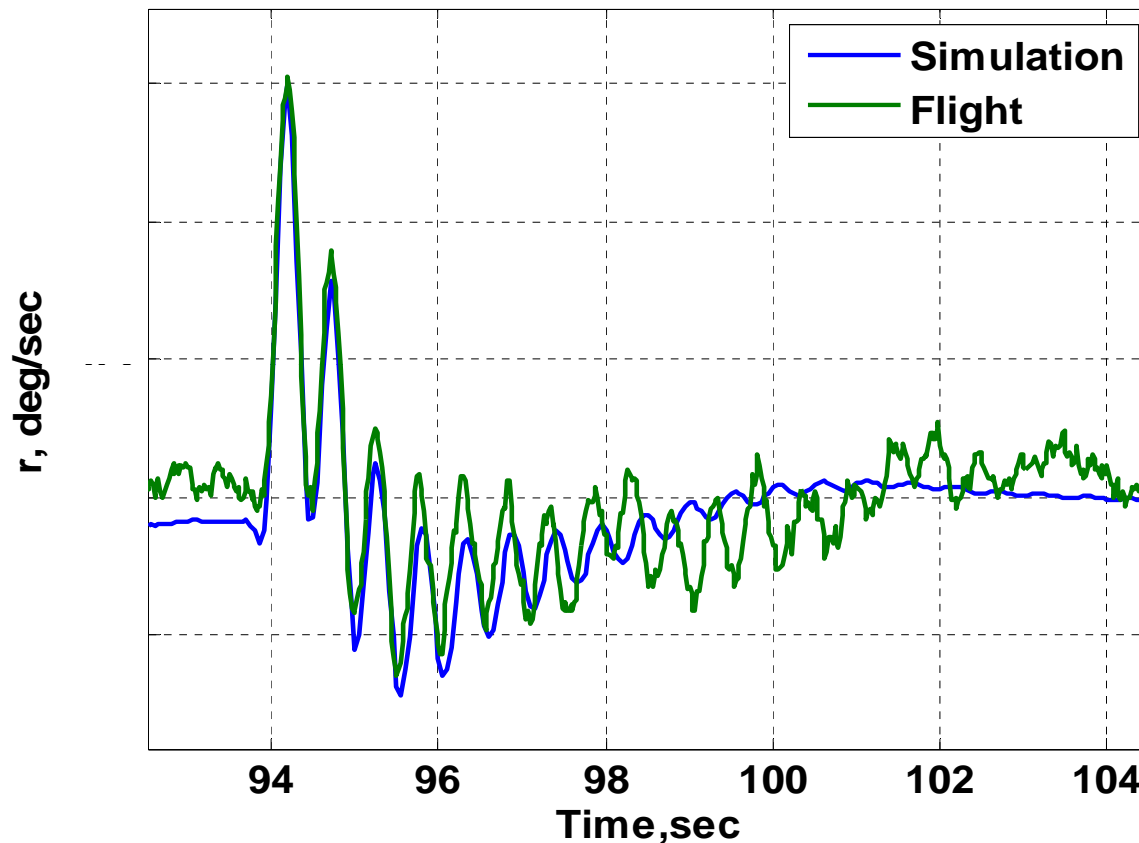
- ◆ Quick look shows closed-loop 1<sup>st</sup> mode flight damping about 20% lower than simulation.

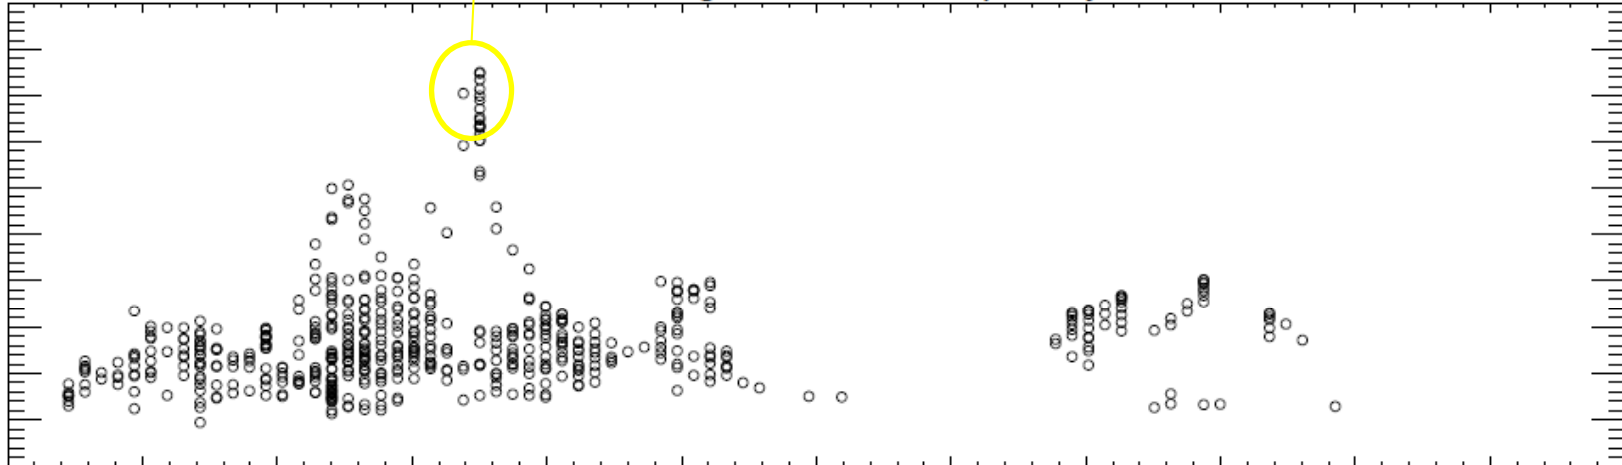
77 to 79 seconds

- ◆ 1L thrust oscillation peaked between T+77 and T+79 seconds
- ◆ Substantial margin between recommended load and actual load
  - Peak pressure was about 1/3 of the predicted value
  - Frequency was ~15 Hz

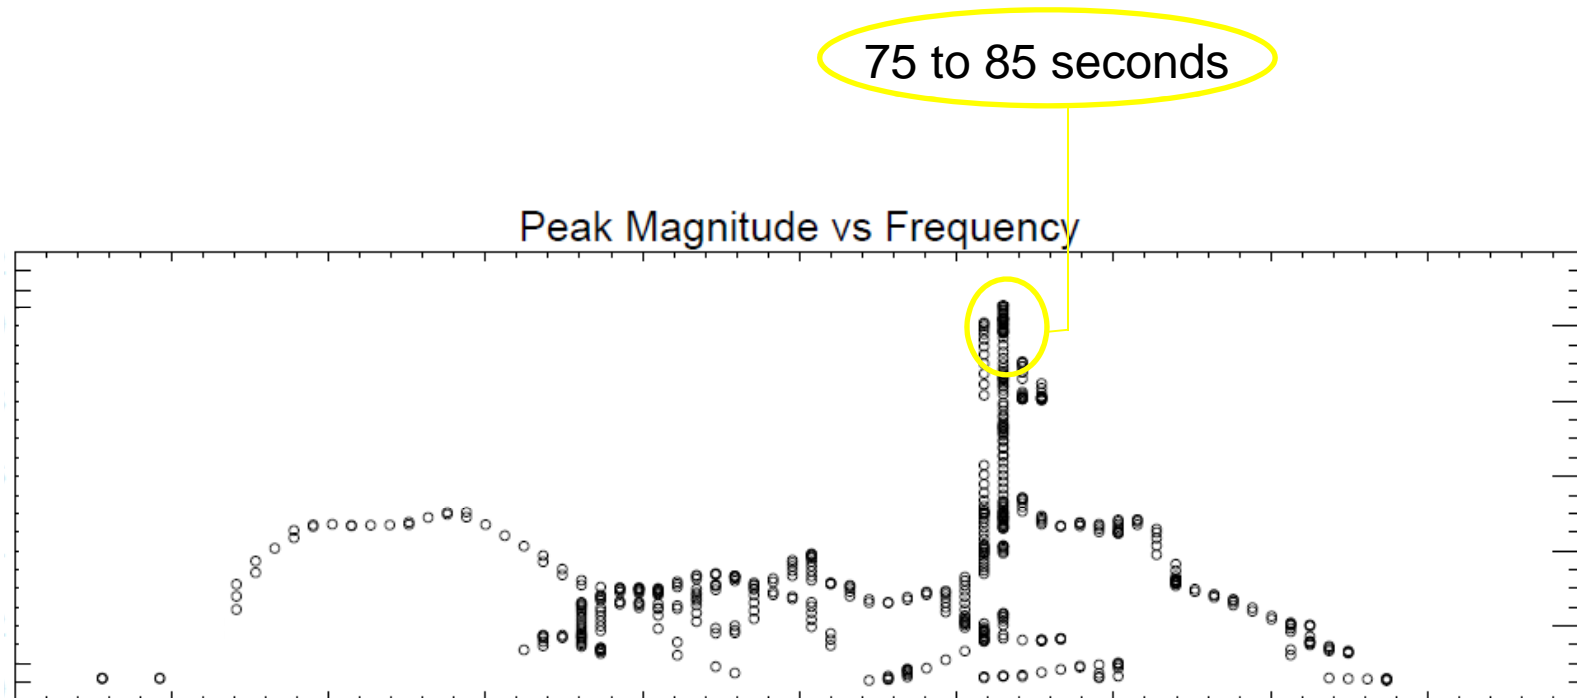
- ◆ 2L thrust oscillation peaked between T+75 and T+85 seconds
- ◆ Substantial margin between recommended load and actual load
  - Peak pressure was about 1/2 of the predicted value
  - Frequency was ~ 29 Hz

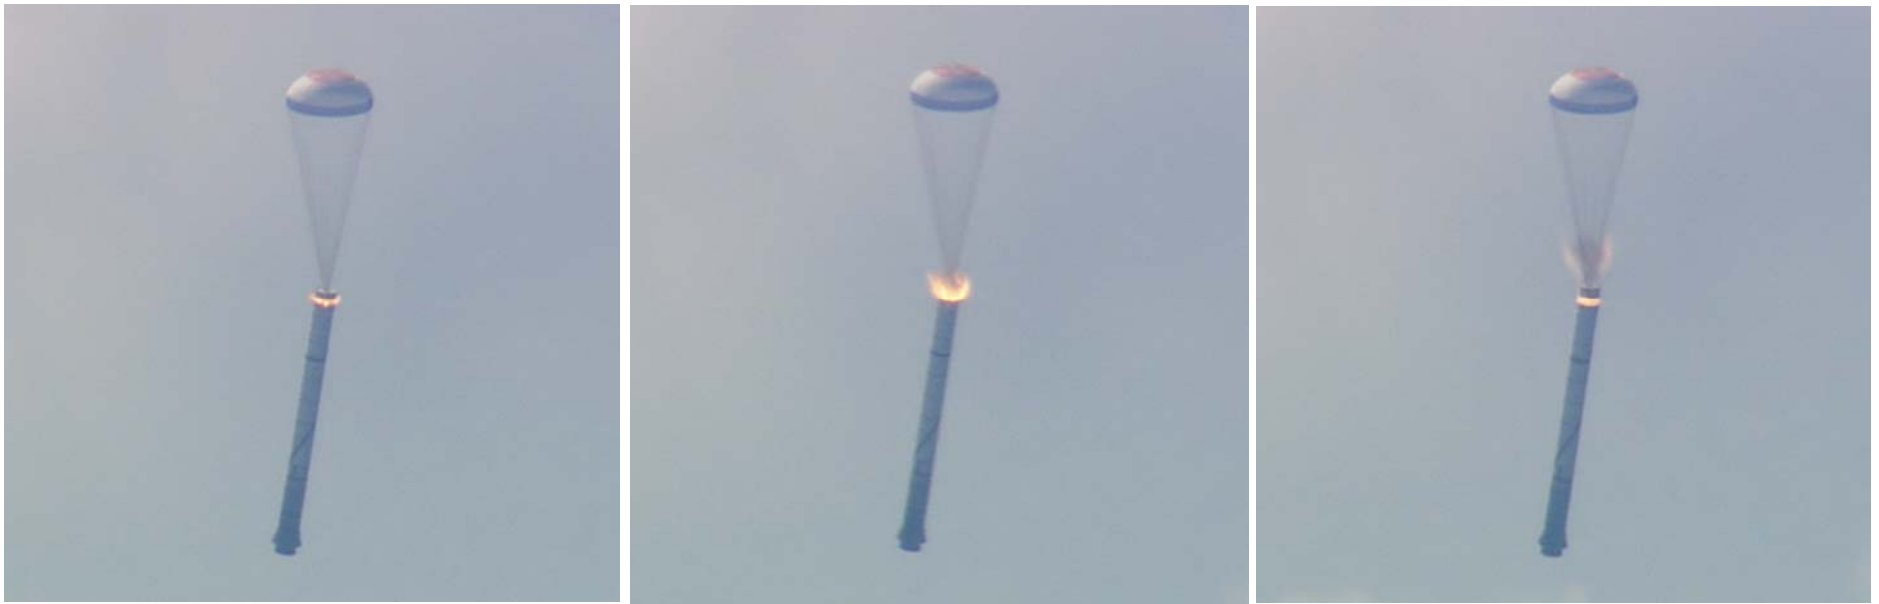
## ◆ Three separation connectors on the Forward Skirt dome did not separate

- Pendulum effect under the drogue chute may have caused an off center pull
- A improper disconnect failure scenario was identified prior to launch and determined not to have any significant effects to the system
- No loss of functionality of the connectors

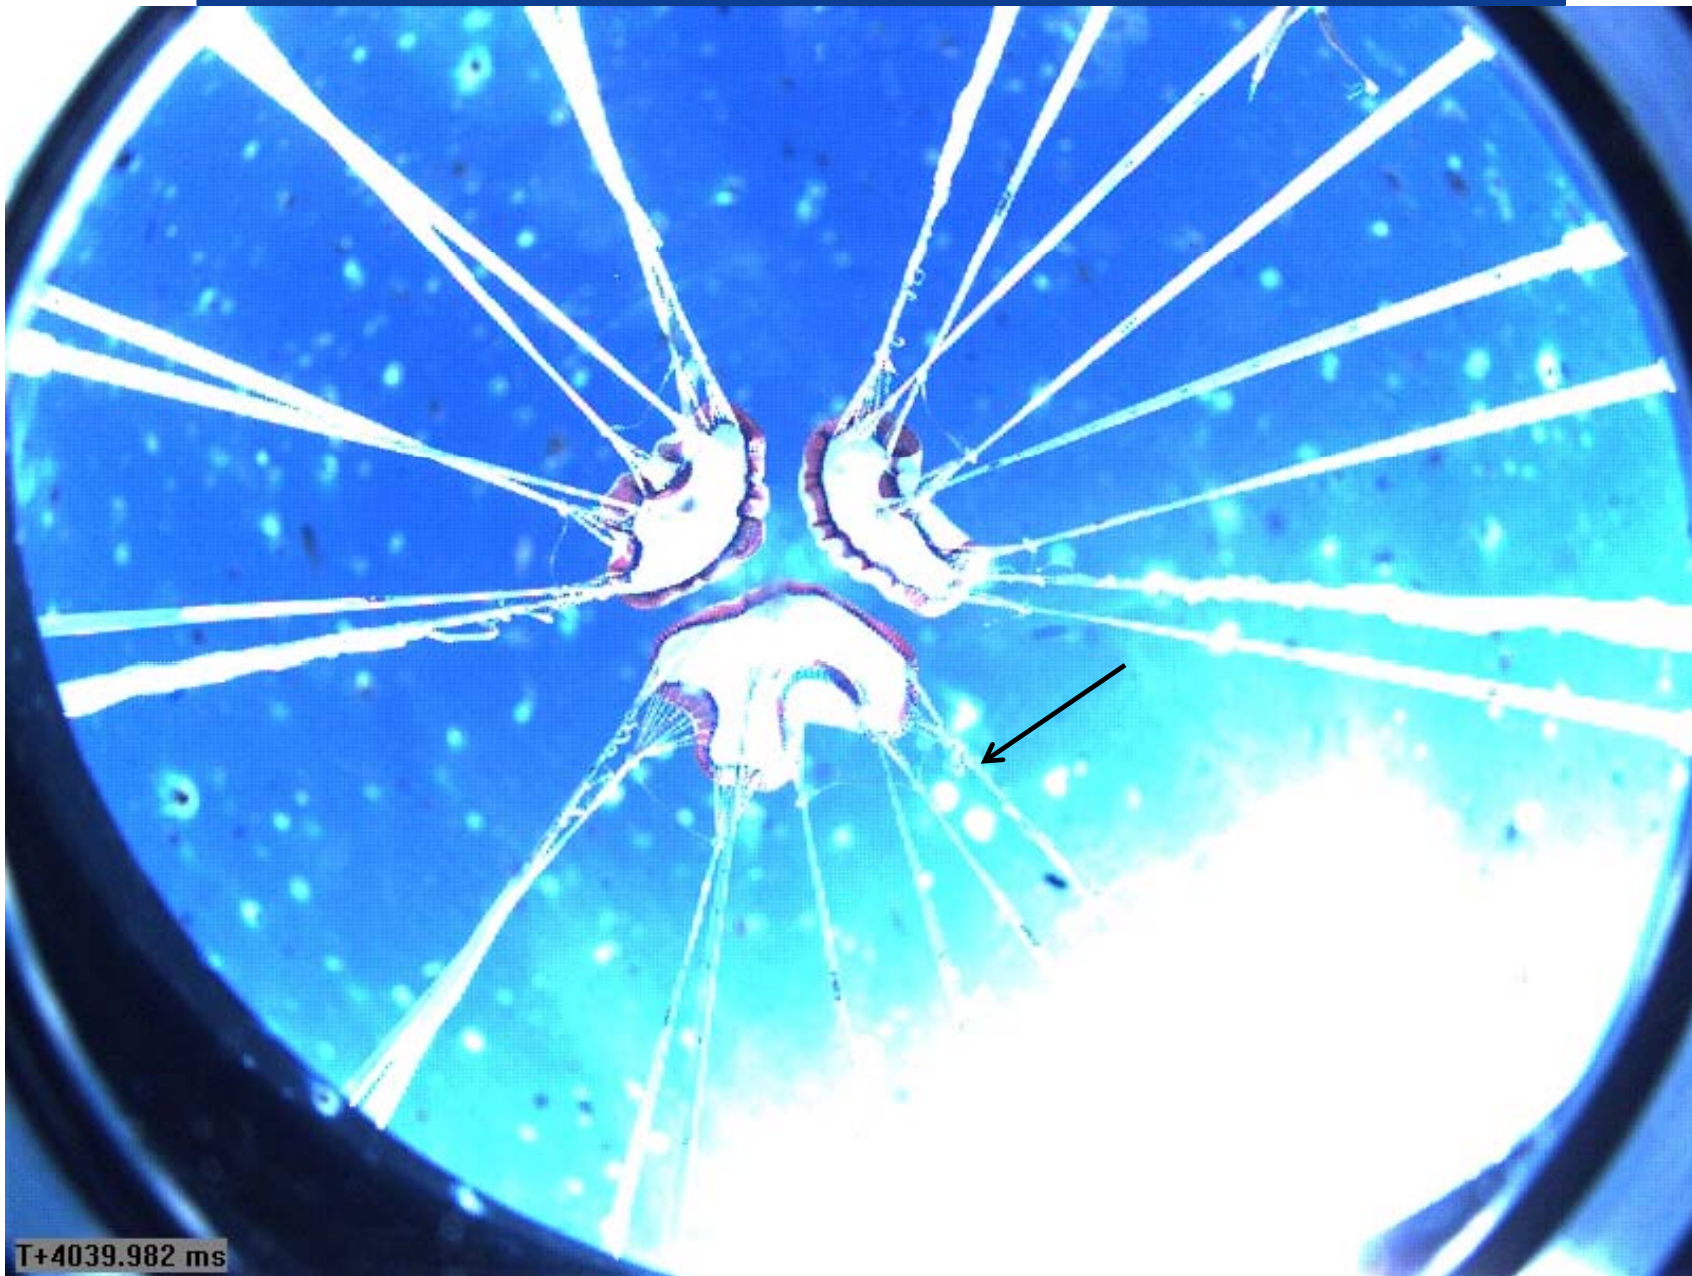
# Main Parachute Failure

- ◆ One of the main parachutes failed at initial inflation
- ◆ 1<sup>st</sup> parachute may have “dis-reefed” prematurely allowing parachute to inflate too quickly
  - Increased initial load on parachute and riser line system
  - Salt Water Activation Release (SWAR) hardware exhibits damage representative of an overload
- ◆ A second parachute then partially failed
  - Assessment underway
